Perimeter Fire Barrier Systems

Taking a team approach
to fire-safe construction

by Tony Crimi, P.Eng., M.A.Sc.

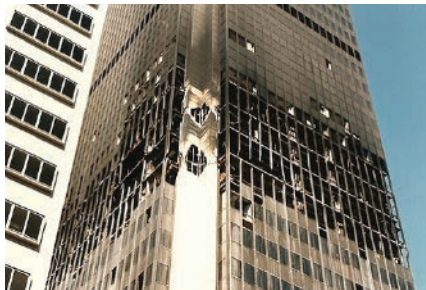
On February 12, 2005, a fire started on the 21st floor of the Windsor Tower or Torre Windsor (officially known as Edificio Windsor) in Madrid, Spain. The building was a 32-story concrete building with a reinforced concrete central core. It was not sprinklered, and had been undergoing progressive refurbishment over a three-year period. The fire burned

for 20 hours, spreading to all levels above the second floor.

At the time of construction, the Spanish building code did not require perimeter firestopping or perimeter columns and internal steel beams to be fire-protected. As a result, the original existing steelwork was left unprotected and the gap between the original

cladding and floor slabs was not firestopped. In fact, these weak links in the fire protection of the building were being rectified in the refurbishment project at the time of the fire. Since the building adopted the ‘open-plan’ floor concept, effectively, the fire compartmentation could only be floor-by-floor (about 40 x 25 m [131 x 82 ft]). However, the lack of perimeter fire barriers in floor openings and between the original cladding and the floor slabs led to a failure of the vertical compartmentation, and the complete collapse of the building.

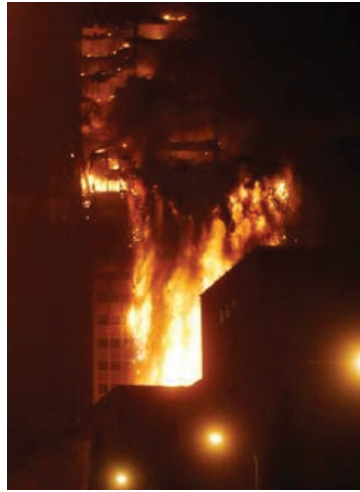
In 2005, a fire started on the 21st floor of Torre Windsor in Madrid. The 32-story concrete building, with a reinforced concrete central core, was not sprinklered, and had been undergoing progressive refurbishment over a three-year period. At the time, the Spanish building code did not require perimeter firestopping or perimeter columns and internal steel beams to be fire-protected.

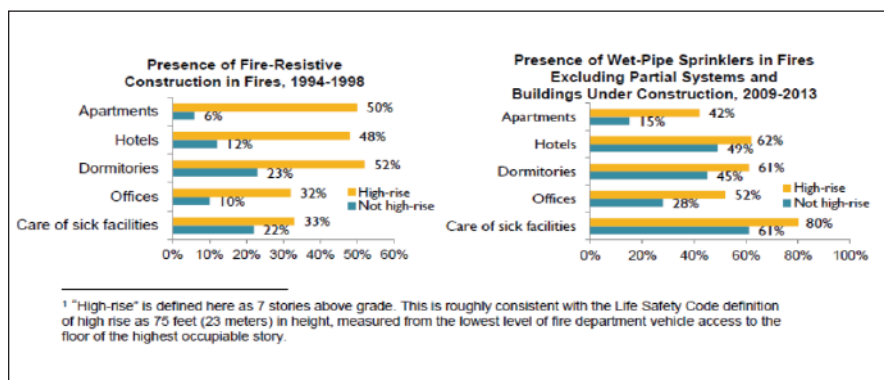
The fire death rate per 1000 fires and the average loss per fire are generally lower in high-rise buildings than in other buildings of the same property use. The former are more likely than shorter buildings to have fire-resistive construction and wet-pipe sprinklers that help prevent fire spread. This data comes from "High-rise Building Fires Report," a November 2016 National Fire Protection Association (NFPA) report by M. Ahrens.

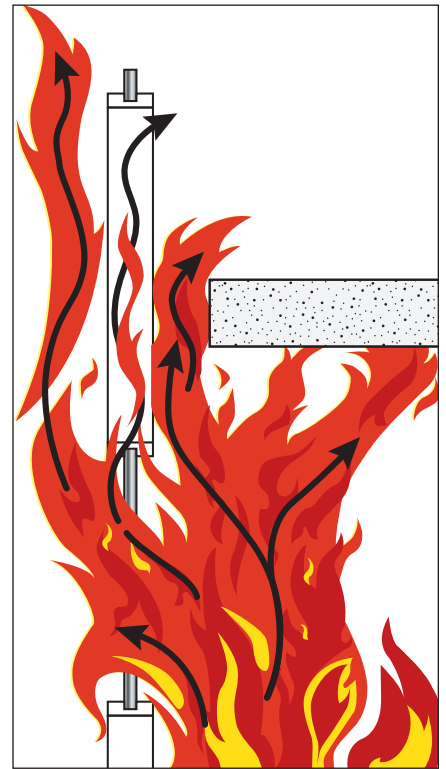
An illustration of the various paths a spreading fire can take.

Conceptually, the easiest way to look at the three paths for the fire to spread to adjacent floor levels at the exterior wall is:

- through the void spaces created between the edge of the floor and an exterior curtain wall—these are protected by perimeter fire barrier systems per ASTM E2307, *Standard Test Method for Determining Fire Resistance of Perimeter Fire Barriers Using Intermediate-scale, Multi-story Test Apparatus*, and ASTM E2393, *Standard Practice for Onsite Inspection of Installed Fire-resistive Joint Systems and Perimeter Fire Barriers*;
- via the voids or cavities within the exterior curtain wall, with fire spreading by a path within the concealed space of the exterior wall, or along the outer surface of the exterior wall—these are protected by assemblies compliant with NFPA 285, *Standard Fire Test Method for Evaluation of Fire Propagation*
