**Aged Insulation
Evaluation**

Report 4162.032-
022317

Summary Report of Aged Insulation Evaluation

The North American Insulation Manufacturers Association contracted with Home Innovation Research Labs to evaluate aged-performance of thermal insulation within exterior wall cavities of residential wood frame buildings. The study reports on 8 samples of fiber glass batt insulation that were taken from existing residential buildings that had been in service for at least 30 years.

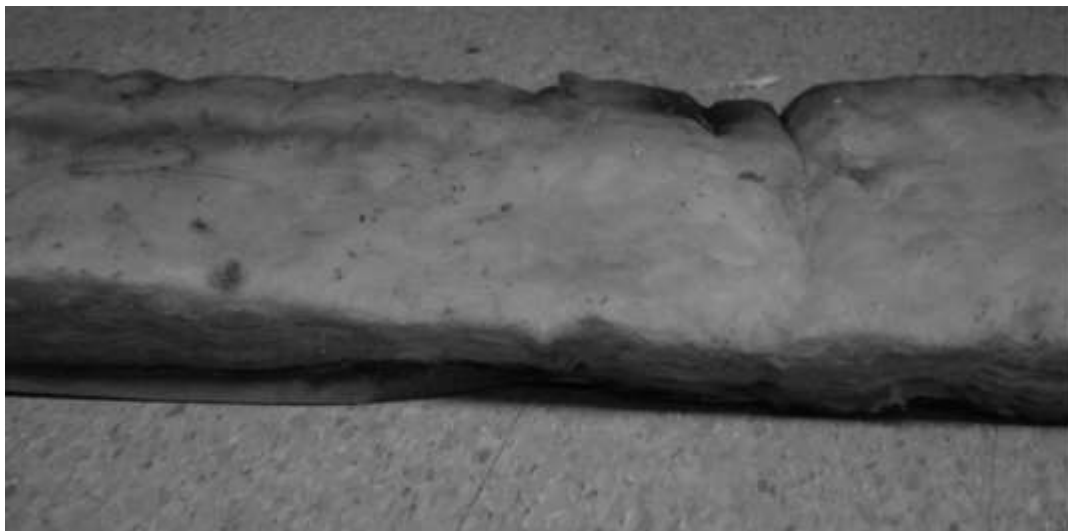
Figure 3
Sample No. 1 – R11 Faced Fiberglass Insulation

Fiberglass Sample No. 1 has kraft paper facing as shown in Figure 3. The material is not damaged and clean section was cut for thermal testing.

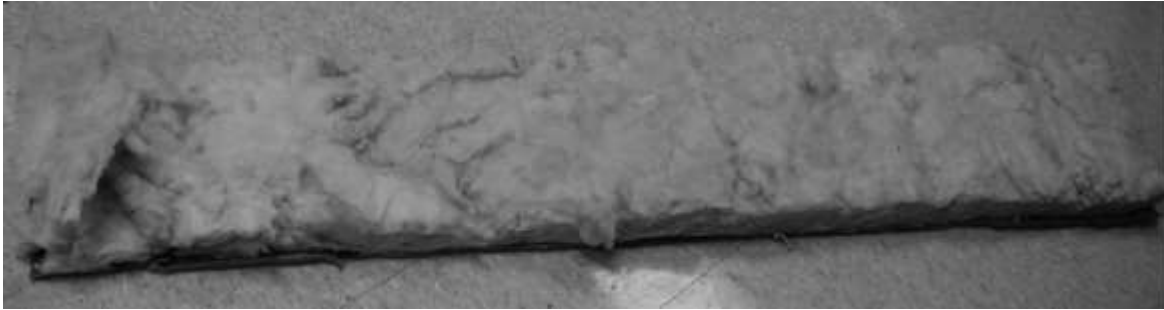
Figure 4
Sample No. 2 – R13 Faced Fiberglass Insulation

Fiberglass Sample No. 2 has kraft paper facing, as shown in Figure 4. The material has small end sections damaged and clean section was cut for thermal testing.

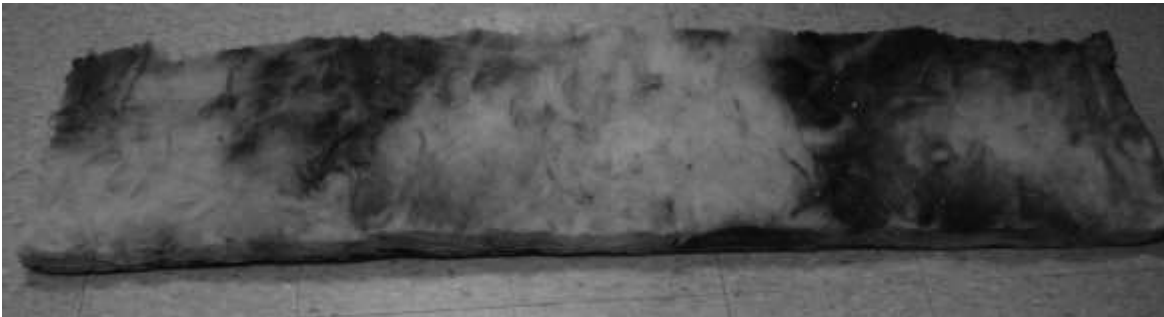
Figure 5
Sample No. 3 – R7 Faced Fiberglass Insulation

Fiberglass Sample No. 3 has kraft paper facing, as shown in Figure 5. The material has discoloration on the unfaced surface and clean section was cut for thermal testing.

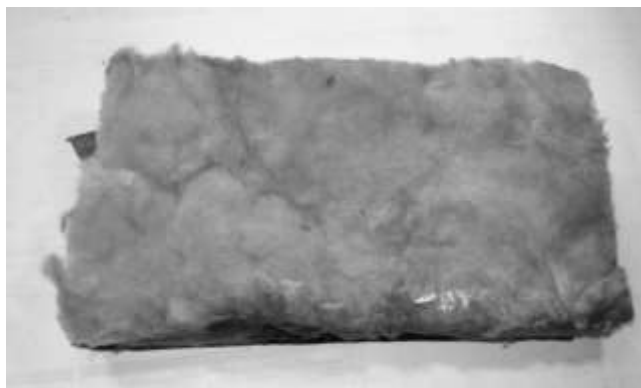
Figure 6
Sample No. 4 – R11 Faced Fiberglass Insulation

Fiberglass Sample No. 4 has kraft paper facing, as shown in Figure 6. The material has discoloration around edges on the unfaced surface, but no damage was found.

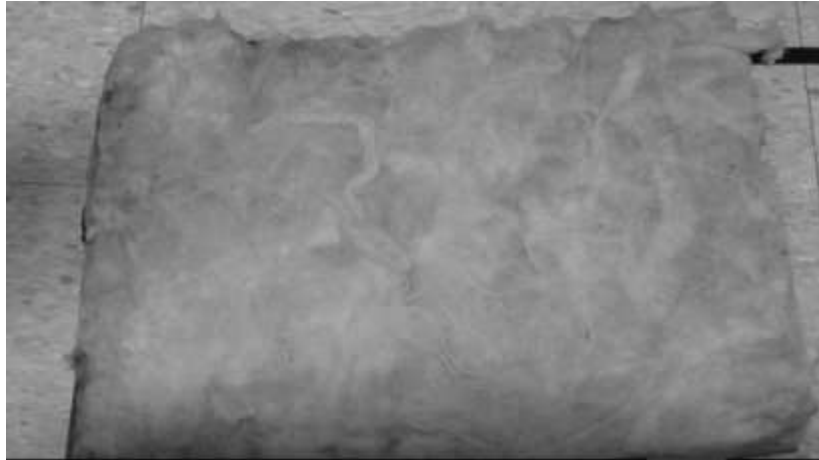
Figure 7
Sample No. 5 – R9.6 Faced Fiberglass Insulation

Fiberglass Sample No. 5 has kraft paper facing, as shown in Figure 7. The material has slight discoloration around edges on the unfaced surface, but no damage was found.

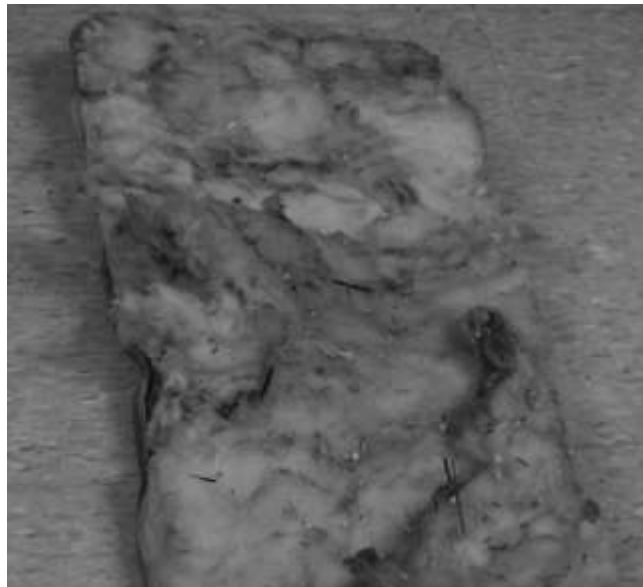
Figure 8
Sample No. 6 – R11 Faced Fiberglass Insulation

Fiberglass Sample No. 6 has kraft paper facing, as shown in Figure 8. The material has slight discoloration and tear. Specimens were taken from undamaged sections of the materials.

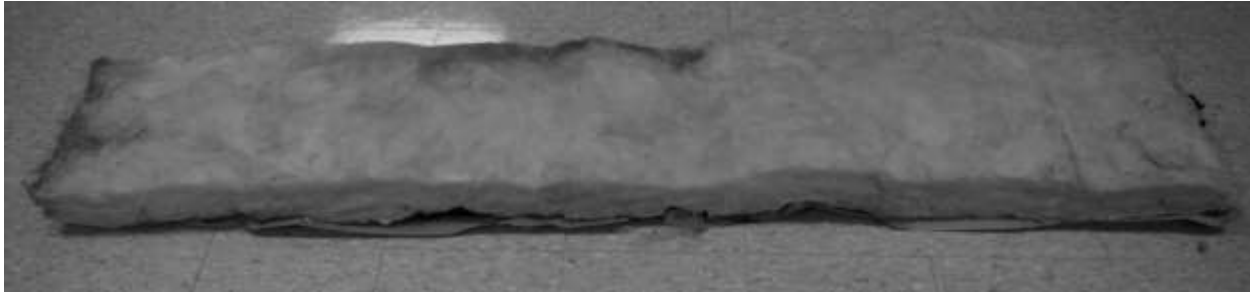
Figure 9
Sample No. 7 – R11 Faced Fiberglass Insulation

Fiberglass Sample No. 7 has kraft paper facing, as shown in Figure 9. The material has slight discoloration around the edge of unfaced material, but no damage was found.

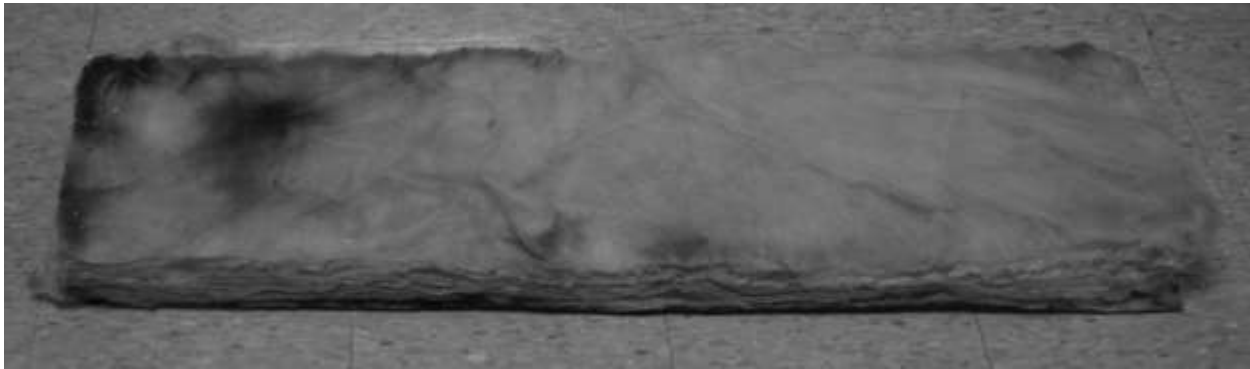
Figure 10
Sample No. 8 – R11 Faced Fiberglass Insulation

Fiberglass Sample No. 8 has kraft paper facing, as shown in Figure 10. The material has discoloration of the unfaced material, but no damage was found.
