Report of Results
for
NAIMA
11 Canal Center
Plaza, Suite 103,
Alexandria, VA 22314

Wall Cavity Insulation
Settling Test of Blown
In Fiberglass Insulation

Report
4162.029.111815D

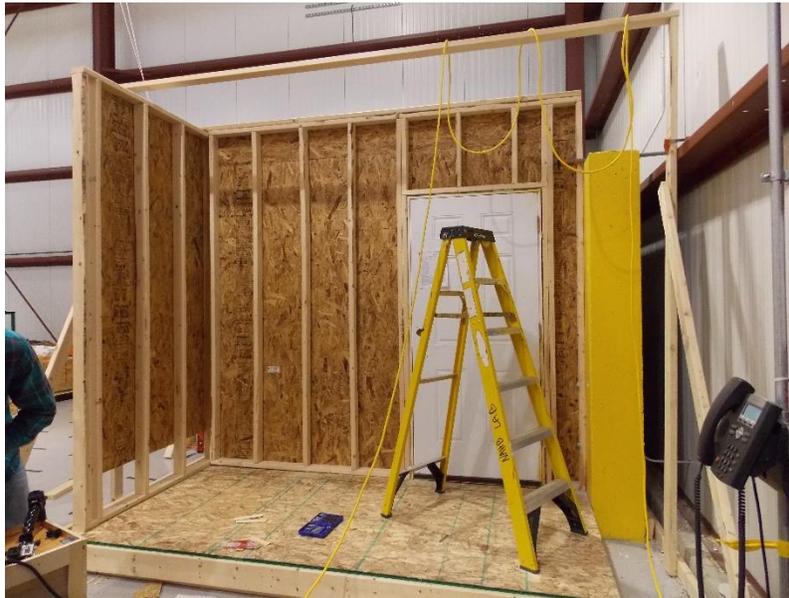
Figure 4. Photo of the Test Wall

The four full cavities (as shown in Figure 4) between and door and the shorter stabilizing wall were the cavities where the insulation to be tested was installed. On the exterior of the wall, one 7/16" thick OSB sheathing was installed and 1/2" gypsum board was attached to the studs using drywall screws after the insulation was installed. There are four 6" x 3" observation windows at the top of the gypsum board, centered on each of the 4 wall cavities where the insulation meets the top plate of the wall. These windows were made using 1/4" thick

polyethylene sheet cut to fit in place. The polyethylene observation window was installed flush with the back side of the gypsum board so it was in contact with the insulation.

As Figure 4 shows, the exterior door was installed in the longer section of the test wall was anchored to the reaction wall (yellow color in Figure 4). The automated pneumatic open/closure mechanism, as shown in Figure 5, was attached to the door on the exterior/OSB side of the wall. It includes three sections: a cylinder operated by compressed air, a control system of the cylinder operation, and a vibration measurement instrument.

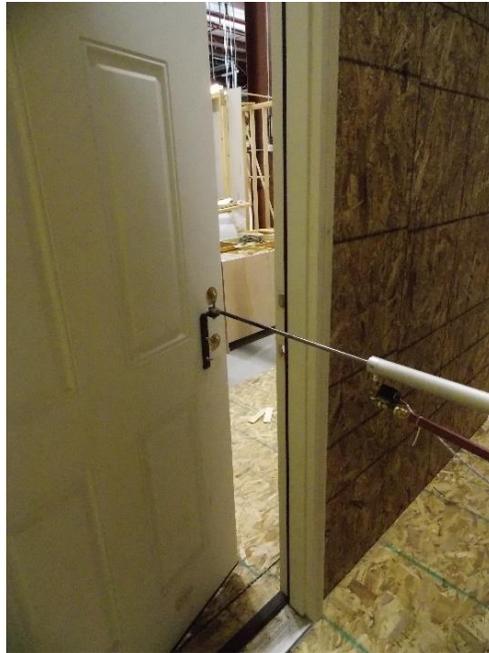
Figure 6. Cylinder of Vibration Mechanism

The cylinder that opens and closes the door causing the cyclic vibration to the test wall was attached to the door on the exterior side through the rod using bolts and brackets as shown in Figure 6. The cylinder body was anchored to a wall parallel to the test wall.

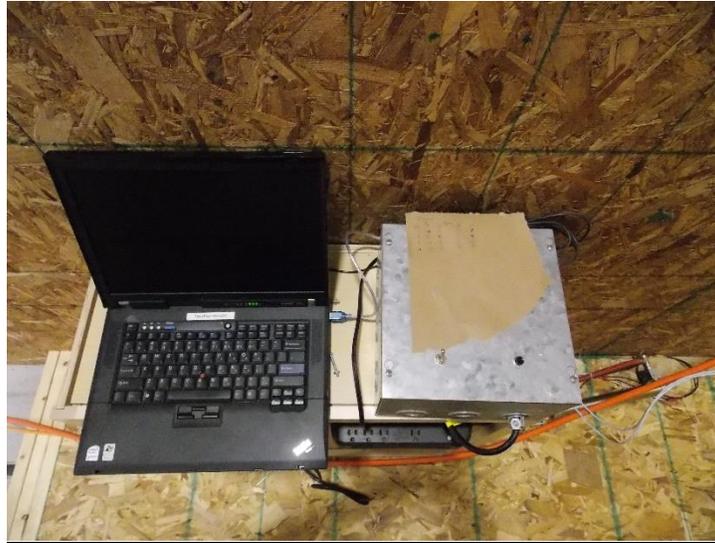
Figure 7. Control of the Vibration Mechanism

A PLC (programmable logic control) control using a control box and a laptop computer was used to regulate the flow of the compressed air to and from the cylinder as shown in Figure 7. All control valves, contacts and wiring are contained in the control box. The computer has the control software program that can be used to change the total number of vibration cycles and frequency of the cycling, start and stop of the air supply thus the testing, and record the actual total number of the cycles. Also the software program terminates the cycling when the actual number of cycles reaches the setpoint value (specified number of cycles). The magnitude of the vibration, was adjusted by a regulator valve on the compressed air supply line. The desired vibration was achieved by regulating the pressure of the air supply once the measured impact was reached using an appropriate vibration measurement instrument.

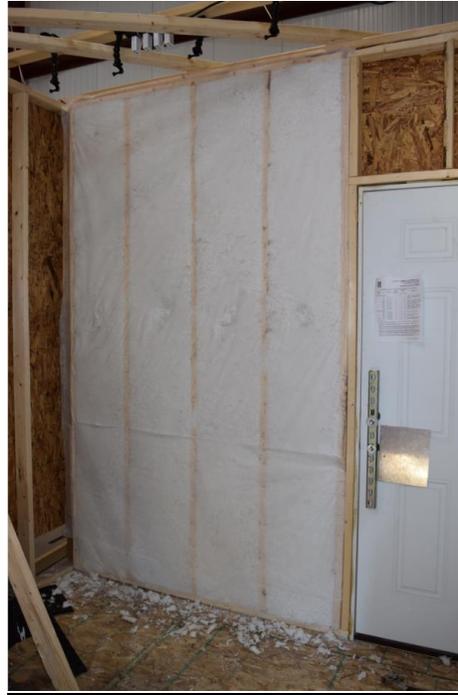
Figure 10. Test Wall with Blown in fiberglass Insulation Installed

The installation of the blown in fiberglass wall cavity insulation was conducted by a local insulation contractor and witnessed by the NAIMA representative. The installation was conducted on July 23, 2015. Figure 10 shows the installed insulation before drywall was installed.

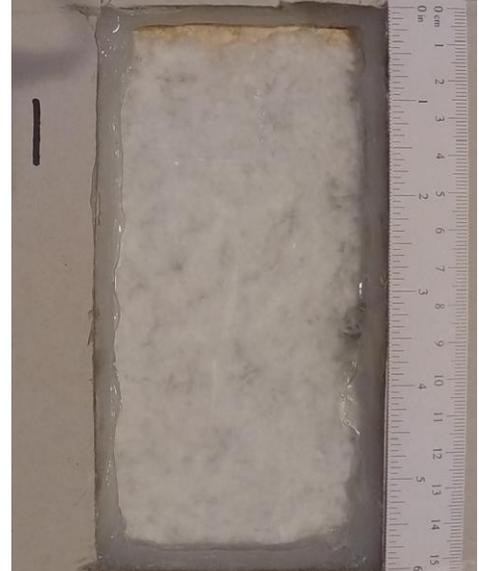
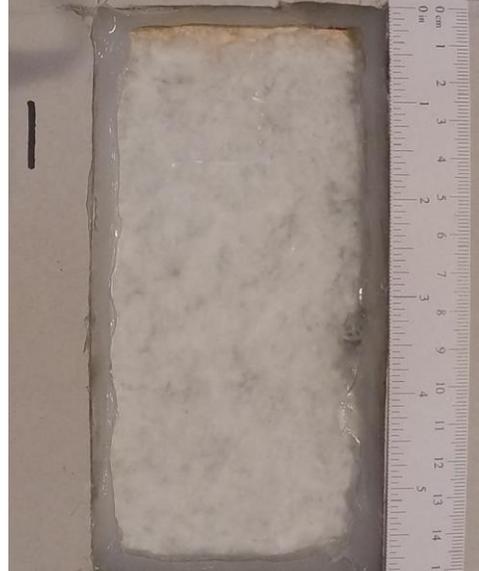
Table 4. Observation of Cavity Insulations for the First Cycling

Cavity No.	0	1
Start First of Cycling (0 cycles) (07/25/15)

End of First Cycling (32,850 cycles) (07/26/15)

The blown in fiberglass insulation in all four wall cavities did not show any significant or observable changes, including settling, before and after the two sets of doors 32,850 opening and closing cycles. Tables 4 and 5 show the photos for each cavity before and after the 2 sets of 32,850 cycles each (65,700 total).

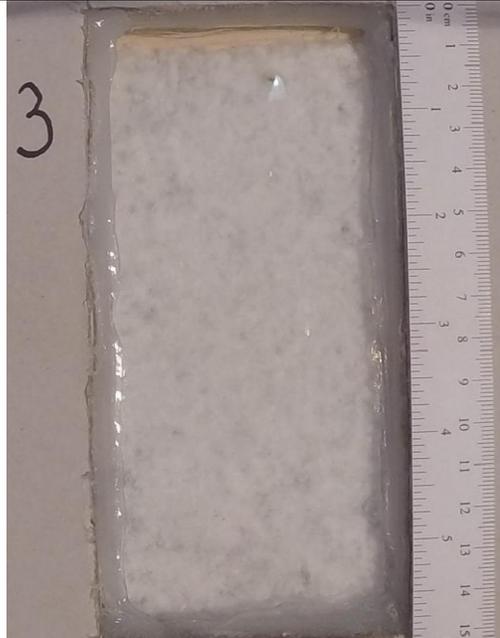
Table 4. Observation of Cavity Insulations for the First Cycling (Continued)

Cavity No.	2	3
Start of First Cycling (0 cycles) (07/25/15)

End of First Cycling (32,850 cycles) (07/26/15)

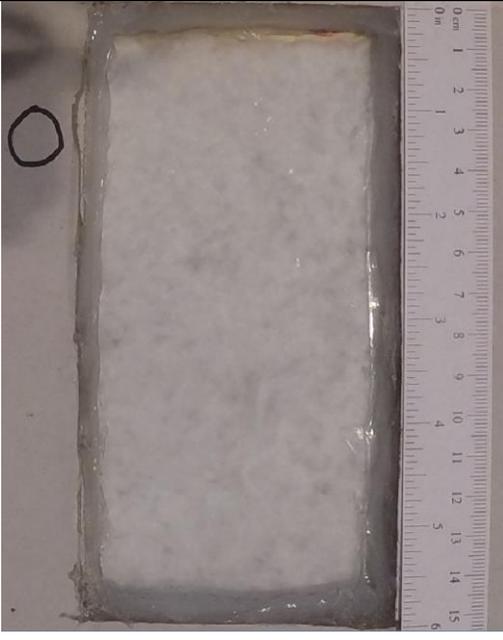
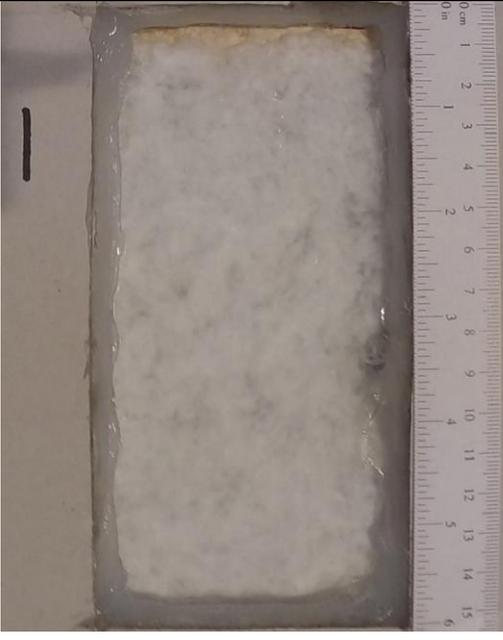
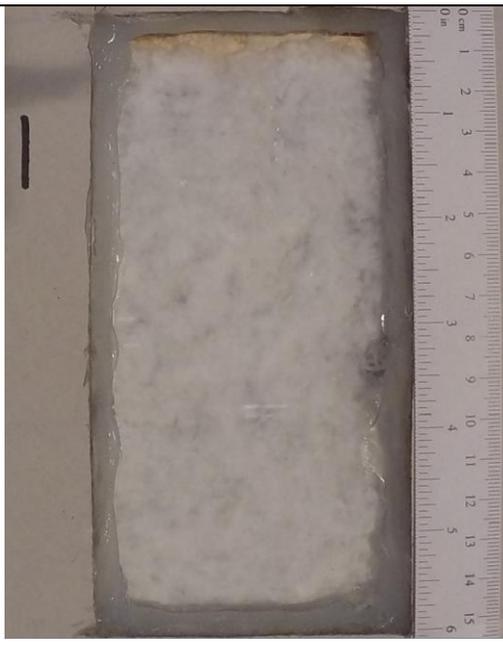
Table 5. Observation of Cavity Insulations for the Second Cycling

Cavity No.	0	1
Start of Second Cycling (32,850 cycles) (07/28/15)

End of Second Cycling (65,700 cycles) (07/29/15)

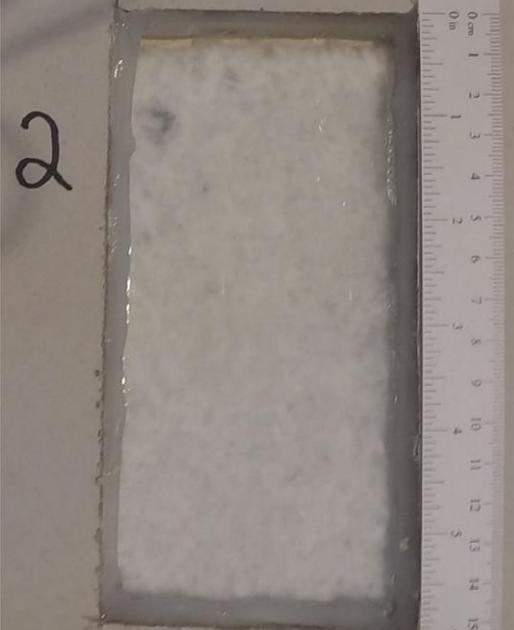
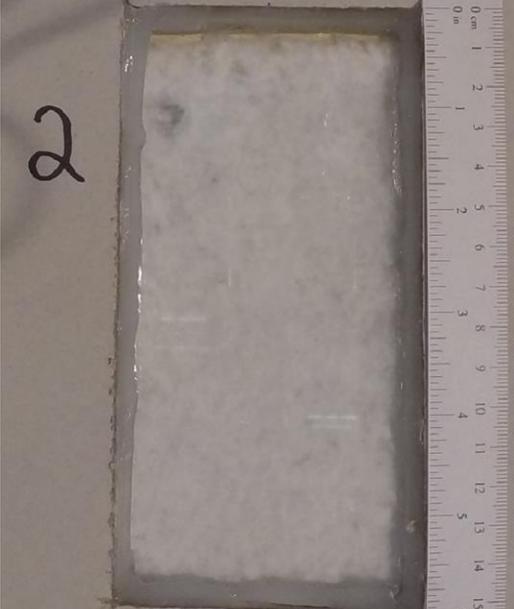
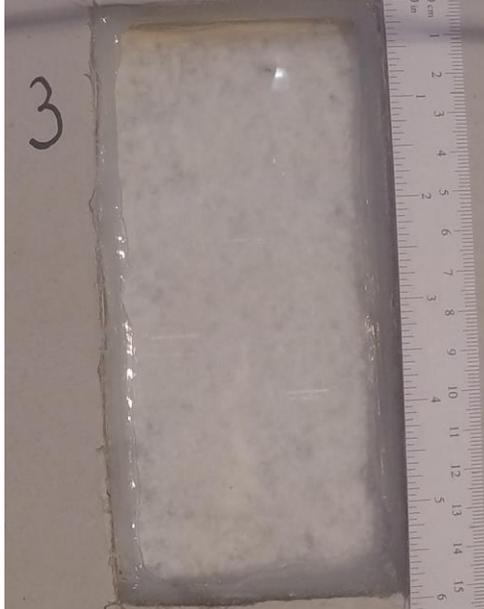
Table 5. Observation of Cavity Insulations for the Second Cycling (Continued)

Cavity No.	2	3
Start of Second Cycling (32,850 cycles) (07/28/15)

End of Second Cycling (65,700 cycles) (07/29/15)
