# Wall Cavity Insulation Settling Test of Rock Wool Batt Insulation

NAIMA

Home Innovation Research Labs 400 Prince Georges Boulevard Upper Marlboro, MD 20774-8731 www.homeinnovation.com

Report # 4162.029.111815C

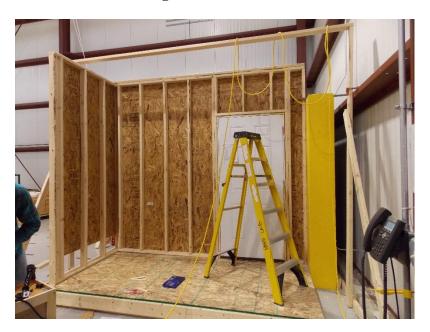
Figure 4. Photo of the Test Wall

The four full cavities (as shown in Figure 4) between and door and the shorter stabilizing wall were the cavities where the insulation to be tested was installed. On the exterior of the wall, one 7/16" thick OSB sheathing was installed and  $\frac{1}{2}$ " gypsum board was attached to the studs using drywall screws after the insulation was installed. There are four 6" x 3" observation windows at the top of the gypsum board, centered on each of the 4 wall cavities where the insulation meets the top plate of the wall. These windows were made using  $\frac{1}{4}$ " thick

As Figure 4 shows, the exterior door was installed in the longer section of the test wall was anchored to the reaction wall (yellow color in Figure 4). The automated pneumatic open/closure mechanism, as shown in Figure 5, was attached to the door on the exterior/OSB side of the wall. It includes three sections: a cylinder operated by compressed air, a control system of the cylinder operation, and a vibration measurement instrument.

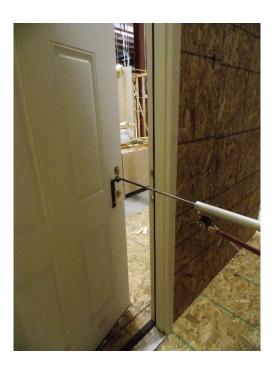
Figure 6. Cylinder of Vibration Mechanism

The cylinder that opens and closes the door causing the cyclic vibration to the test wall was attached to the door on the exterior side through the rod using bolts and brackets as shown in Figure 6. The cylinder body was anchored to a wall parallel to the test wall.

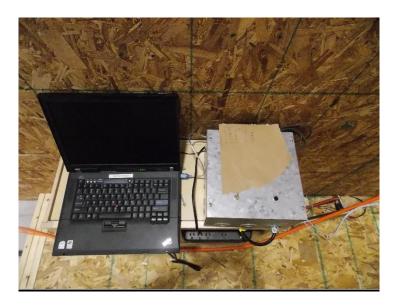
Figure 7. Control of the Vibration Mechanism

A PLC (programmable logic control) control using a control box and a laptop computer was used to regulate the flow of the compressed air to and from the cylinder as shown in Figure 7. All control valves, contacts and wiring are contained in the control box. The computer has the control software program that can be used to change the total number of vibration cycles and frequency of the cycling, start and stop of the air supply thus the testing, and record the actual total number of the cycles. Also the software program terminates the cycling when the actual number of cycles reaches the setpoint value (specified number of cycles). The magnitude of the vibration, was adjusted by a regulator valve on the compressed air supply line. The desired vibration was achieved by regulating the pressure of the air supply once the measured impact was reached using an appropriate vibration measurement instrument.

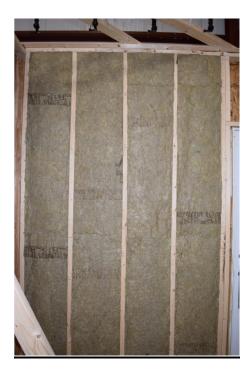
Figure 10. Test Wall with Rock Wool Batt Insulation Installed

The installation of the rock wool batt wall cavity insulation was conducted by the NAIMA representative. The installation was conducted on July 15, 2015. Figure 10 shows the installed insulation before drywall was installed.
