Thermal Metric Summary Report

(June 2015 Update)

Building Science Corporation

June 18, 2015

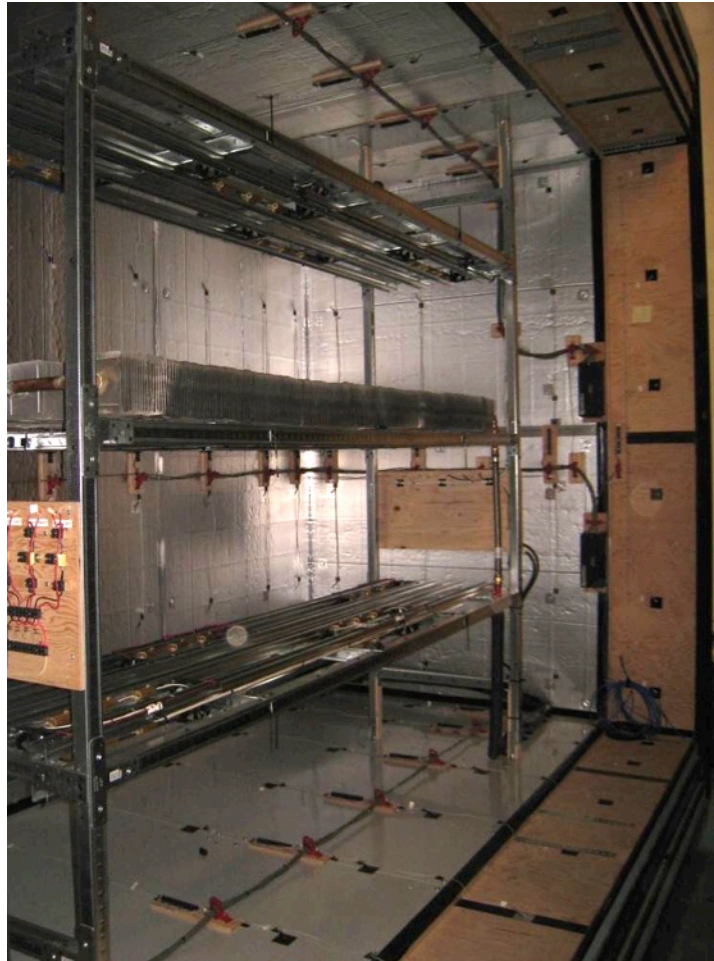
Figure 2 – Upper and Lower Heating Arrays with Cooling Coil in Meter Box

The temperature in the meter box is controlled by electric heat and hydronic cooling. Two heating arrays, each consisting of 16 heaters and 8 mixing fans, are installed in the upper and lower portions of the mixing part of the meter box as seen in Figure 2. The size, number and distribution of the heaters and fans ensure that the temperature is relatively uniform throughout the meter box. Again, voltage and current supplied to the heaters and mixing fans are measured across precision ($\pm 0.01\%$) resistors so that the power may be calculated.

Cooling is achieved by a large, finned convection coil mounted at mid-height in the mixing part of the meter box. The large heat transfer area permits the removal of significant amounts of heat with only modest (e.g. 1°C or 1.8°F) temperature increases across the coil. Distilled water is pumped from a chilled, constant temperature ($\pm 0.05^{\circ}\text{C}$) buffer tank, into the meter box, through the convection coil, and back out of the meter box. The flow rate is measured using a NIST traceable $\pm 0.2\%$ of reading flow meter and the supply and return temperatures are measured using a pair of precision thermistors ($\pm 0.1^{\circ}\text{C}$) and a pair of ultra-precision RTDs ($\pm 0.012\text{ohm}$). These measurements can then be used to calculate the power extracted by the cooling.

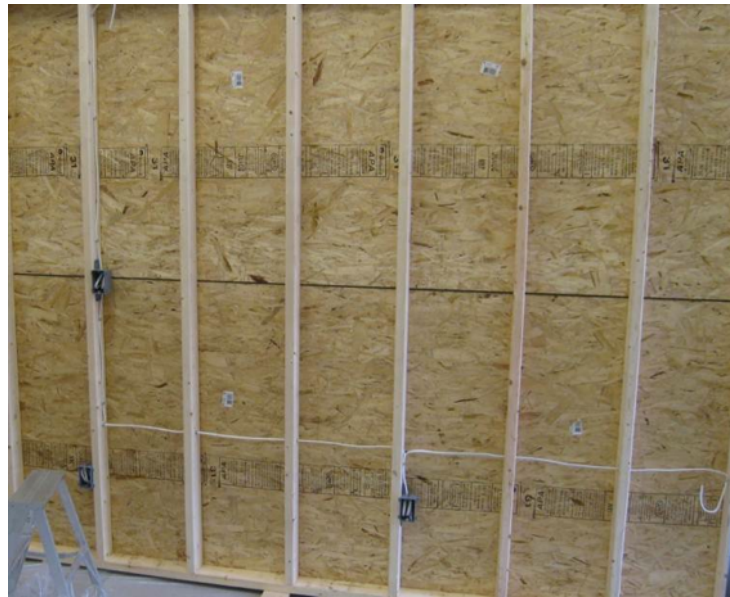
Figure 15 – Electrical Installed and Horizontal Gap Visible

through the necessary studs with a 5/8" drill bit. This creates air leakage paths between the stud bays within the assembly.

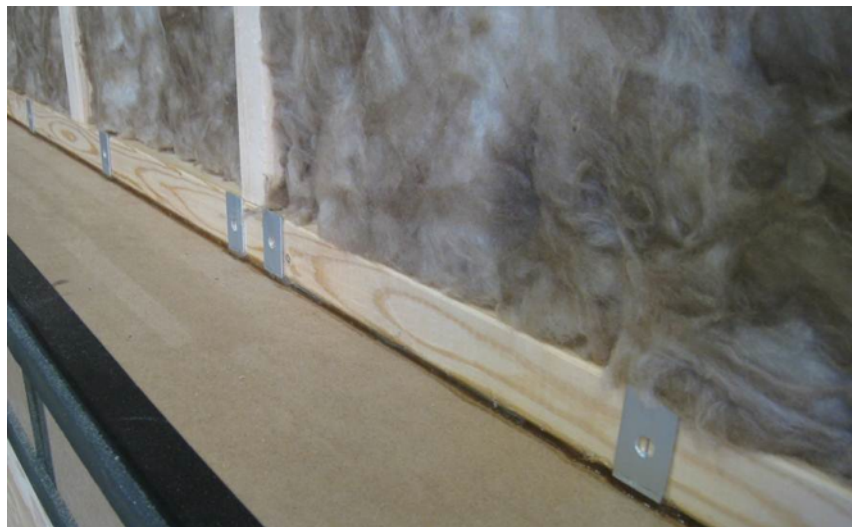
Figure 16 – Drywall Spacers and Fiber Glass Batt Installed

The fiber glass batt was installed in the stud bays to HERS grade I specifications. The two spacers next to one another in Figure 16 are at the point at which two sheets of drywall meet and the corner of both sheets require support.

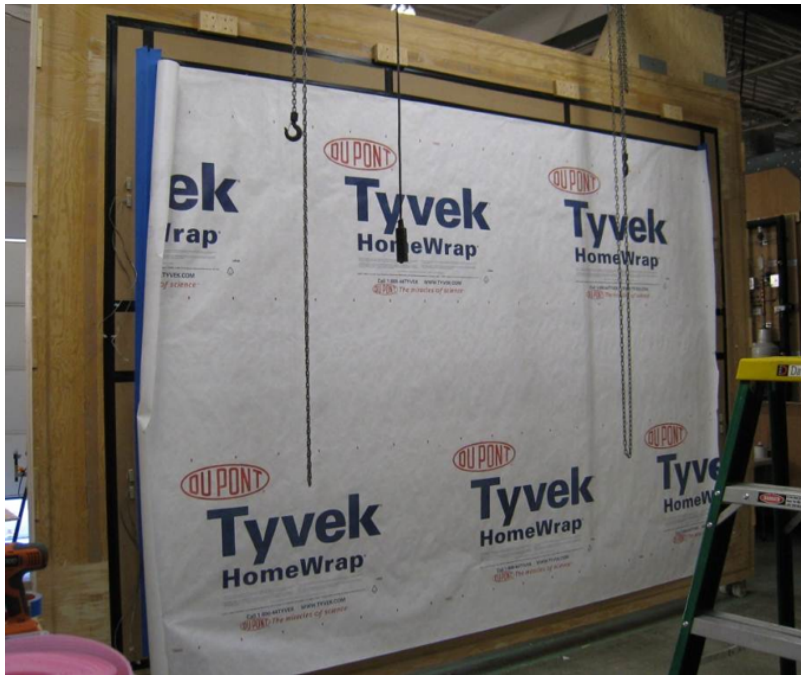
Figure 17 – Tyvek Installed but Untaped

A single continuous sheet of spun-bonded polyolefin (SBPO) housewrap was stapled to the exterior of the wall and was taped on the sides only. Taping on the sides only ensures that air that exits at the mid-height of the sheathing at the imposed gap has a route to escape past the housewrap. This is an expected leakage path for air in an actual wall assembly.

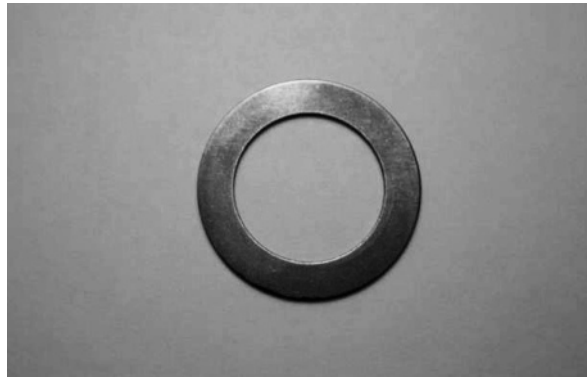
Figure 20 – 1/32" Wall Spacers

Upon air leakage testing the initial wall it was found that the leakage was too high compared to the data found in the literature review. The wall was disassembled and the 1/16" spacers were replaced on the drywall side with 1/32" spacers (Figure 20). The air leakage test was run again, and it was determined the leakage was still above the acceptable bounds. The OSB was removed and the 1/16" spacers were replaced with 1/32" spacers. The air test was run again and this provided acceptable air leakage rates.

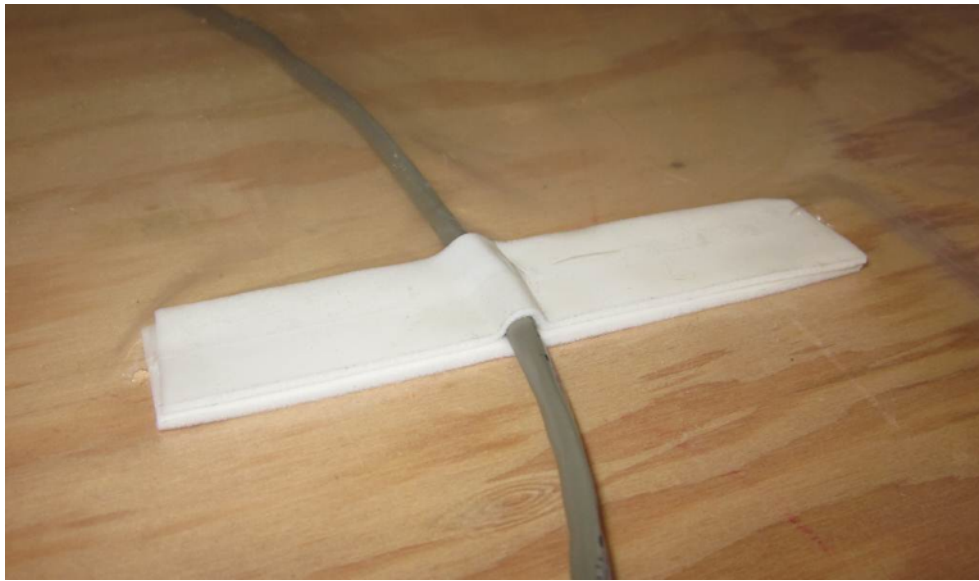
Figure 22 – Sealed Wall Wire Penetration

Sealing of the test wall requires the application and attachment of a continuous sheet of polyethylene on both sides of the wall. A clear polyethylene was chosen to limit changes to the wall surface from radiation. A mid-weight polyethylene was chosen because lightweight polyethylene was difficult to tape in place and heavyweight polyethylene is generally less translucent. The wires for the thermistor sensors had to penetrate the polyethylene, so a method was developed to air seal the penetration. Figure 22 and Figure 23 show the method of air sealing the thermistor sensor wires as they penetrate the polyethylene air seal. A conforming foam double-sided tape is applied to both sides of the slit in the polyethylene and then a double layer of heavy duty tape covers the whole assembly. Figure 24 and Figure 25 show the air sealing of the meter box side of the wall, while Figure 26 and Figure 27 show the air sealing of the climate box side. Thin double-sided tape is used on each sensor location, and slightly thicker double-sided tape is used to create a grid of adhesive locations between the sensors. A double-sided tape seal, seconded with heavy duty tape, creates the perimeter seal.

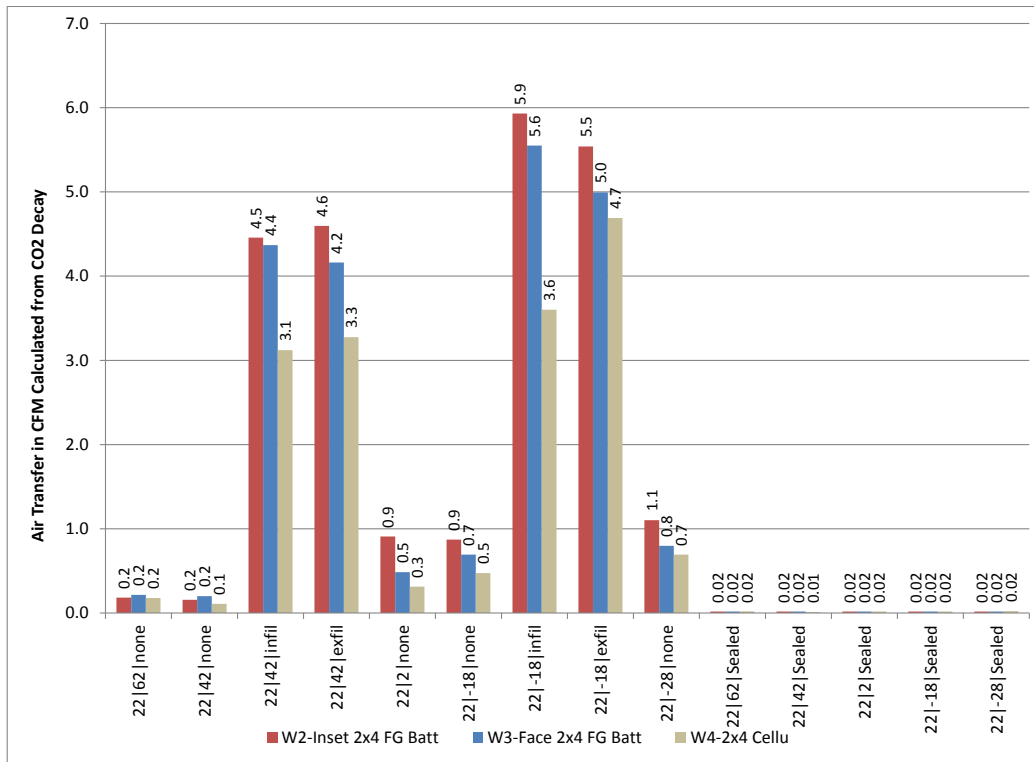
Figure 31 – Wall 2, Wall 3, and Wall 4 Air Transfer Rates in CFM

The infiltration (drawing air from the meter box) and exfiltration (supplying air to the meter box) tests were completed by imposing a 10Pa pressure differential over the wall specimen. Because each wall is different, the amount of air required to create a 10Pa differential varies. Wall 2 (Inset FG 2x4), Wall 3 (Face FG 2x4), and Wall 4 (Cellulose 2x4) have very similar constructions with the only difference being inset versus face-stapled batts versus damp sprayed cellulose. Figure 31 shows the air transfer rates in cubic feet per minute calculated on a mass basis from CO₂ decay. The figure shows that, under normal operating conditions, Wall 3 (face-stapled R13 FG batt) is slightly more resistant to airflow than Wall 2 (inset-stapled R13 FG batt). Wall 4 (damp-sprayed CFI) is more resistant to airflow than Walls 2 and 3. This order of airflow resistance is also visible under imposed 10Pa conditions at almost all temperatures. Note that the air leakage rates are higher at colder temperatures.

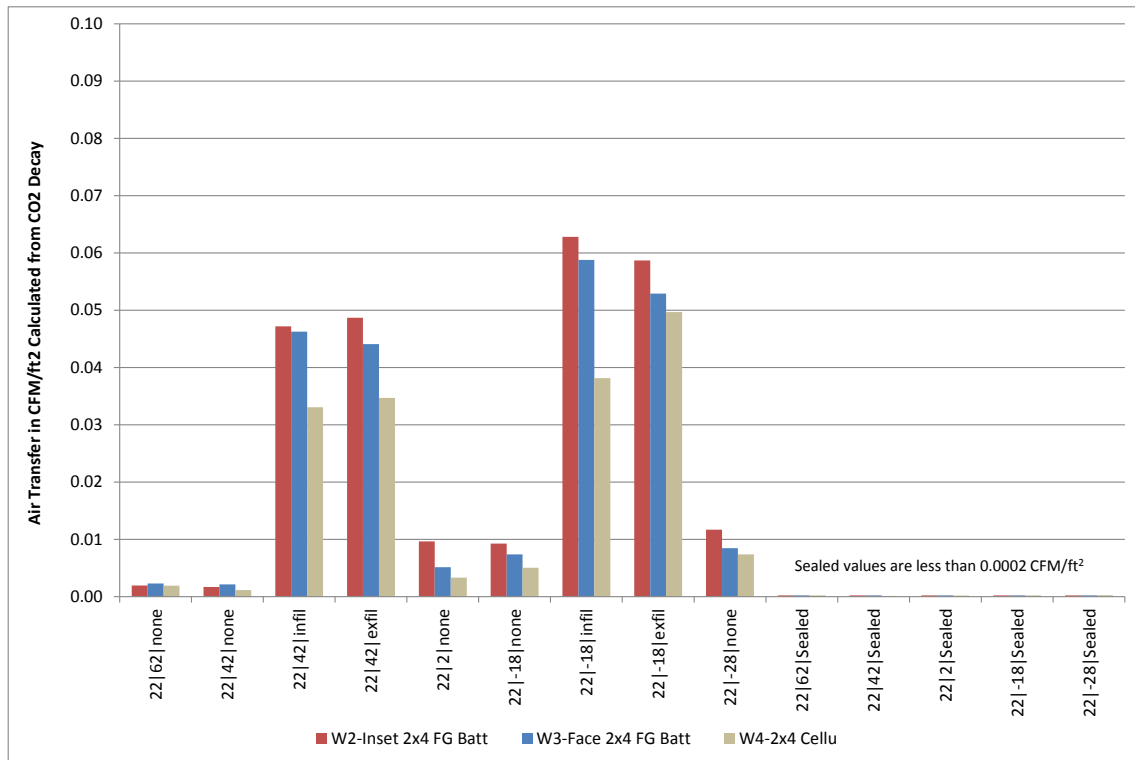
Figure 32 – Wall 2, Wall 3, and Wall 4 Air Transfer Rates in CFM/ft²

Figure 32 shows the information in Figure 31 divided by the area of the wall to show the leakage per square foot of wall surface. Figure 33 shows the energy flow in watts correlating to the information in Figure 31 for Wall 2, Wall 3, and Wall 4. These figures also show that very minimal airflow and heat flow were measured in the sealed wall tests.

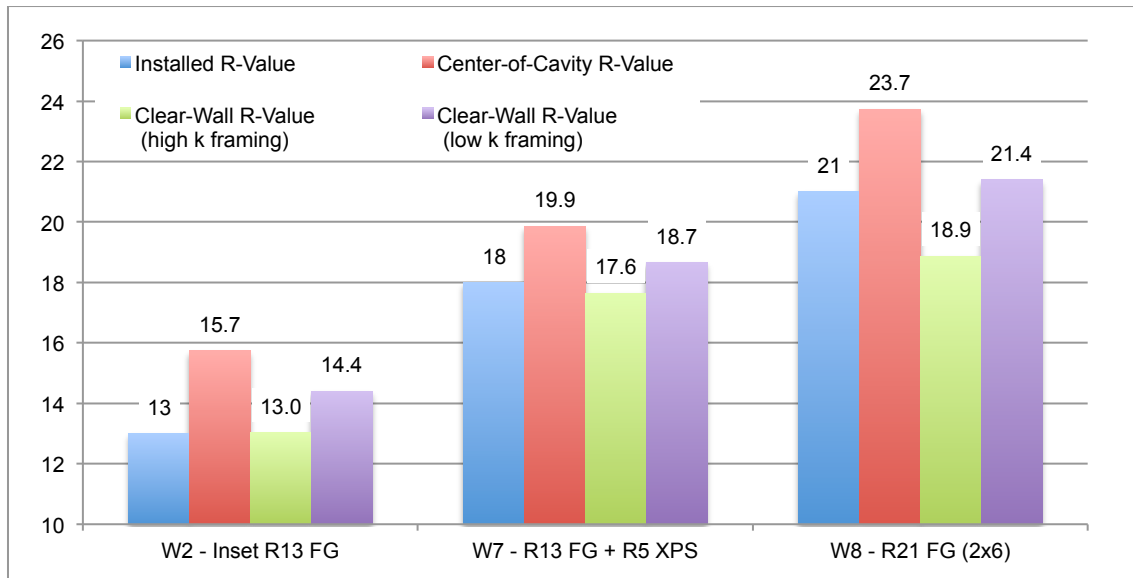
Figure 45 – Common Thermal Metrics for Reference Walls 2, 7 and 8

In the above analysis, the Center-of-Cavity R-values assume a framing factor of 0.137 (i.e. the framing factor of the TM test wall specimens). Studies have shown that, when the full framing of a house is accounted for, the framing factor could be closer to 0.27². If this framing factor were applied, thermal bridging would reduce the assembly R-value by 29%, 20% and 34% for walls 2, 7 and 8 respectively.

Figure 45 **also demonstrates the impact of material property variability.** The green bars represent the Clear-Wall R-values for spruce-pine-fir (S-P-F) framing that has a higher thermal conductivity (high k framing: e.g. $k = 0.15 \text{ W/m}\cdot\text{K}$ or $R1.0 / \text{in.}$) while the purple bars represent the Clear-Wall R-values for spruce-pine-fir framing that has a lower thermal conductivity (low k framing: e.g. $k = 0.076 \text{ W/m}\cdot\text{K}$ or $R1.9 / \text{in.}$) This range of thermal conductivity covers the range of wood densities and moisture content conditions measured in the Thermal Metric Reference Walls. The conductivity of natural materials can vary significantly. The conductivity of site-manufactured materials such as spray polyurethane foam (e.g. ocSPF or ccSPF) and spray-applied, dense-packed or blown fiber insulation (e.g. cellulose or glass fiber) can also vary. Researchers must quantify and document material-specific thermal conductivity and those properties that influence it (including density, moisture content, etc.). Designers and building scientists should be aware of this variability and its potential impact on the thermal performance of wall assemblies.

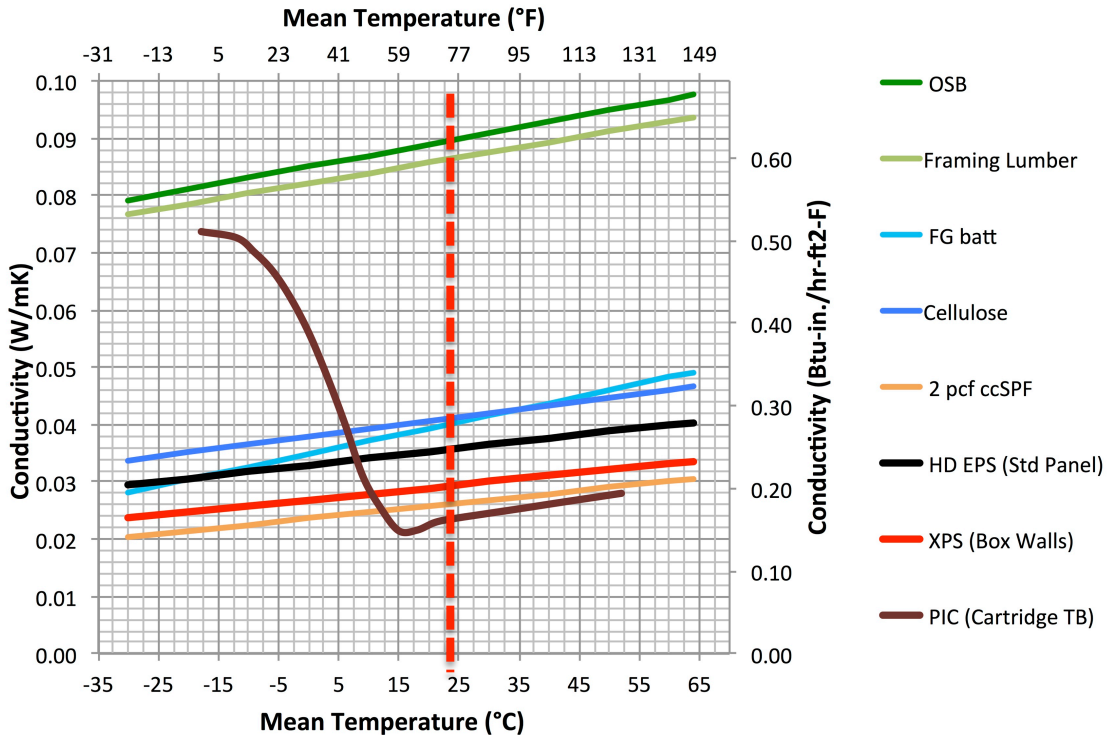
Figure 47 – Measured Temperature Dependency of Selected Materials from the TM Research Project

Temperature dependent material conductivities (or R-value / in.) can be used to calculate Clear-Wall R-values over a range of temperatures. Figure 48 plots predicted and measured Clear-Wall R-values for Wall 2 – Inset-Stapled R13 Kraft-Faced fiber glass Batt. In this plot the dotted line represents the predicted Clear-Wall R-value assuming constant conductivity for each material; the dashed line represents the predicted Clear-Wall R-value when temperature dependency is accounted for; and the blue diamonds indicate the "sealed" assembly (i.e. Clear-Wall) R-values measured in the TM Hot Box.

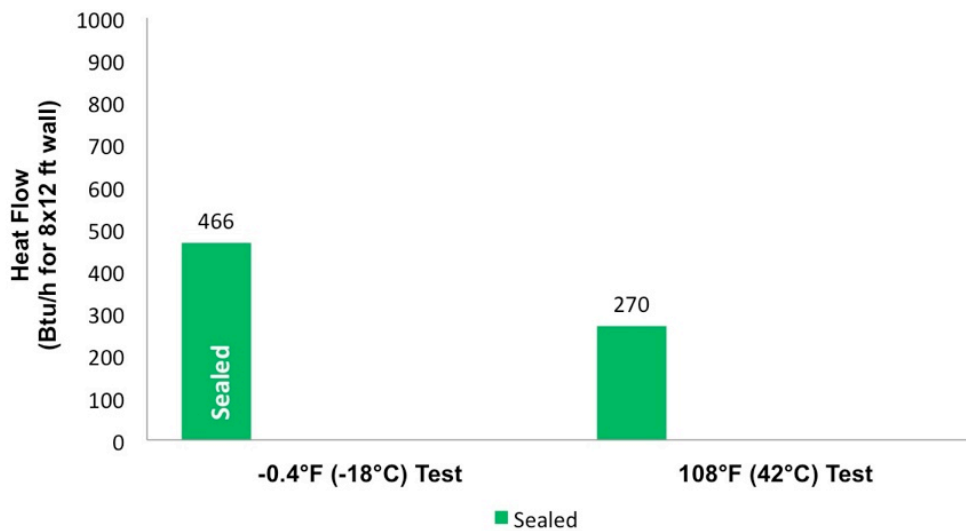
Figure 49 – Measured Heat flows for Wall 2 – Inset R13 FG batt, ‘Sealed’

Figure 49 presents the measured heat flows for the “sealed” scenario of Wall 2. In these tests the wall was “sealed” on the exterior and interior sides using polyethylene sheets and tape, in order to eliminate air leakage through the assembly. In these tests mass flow across the assembly (i.e. from indoors to outdoors or vice versa) is assumed to be none existent. These tests represent the “ideal” or minimum heat flows represented by the simple conduction-only building enclosure heat loss model of Figure 50. These tests provide a baseline for comparing the induced airflow tests.

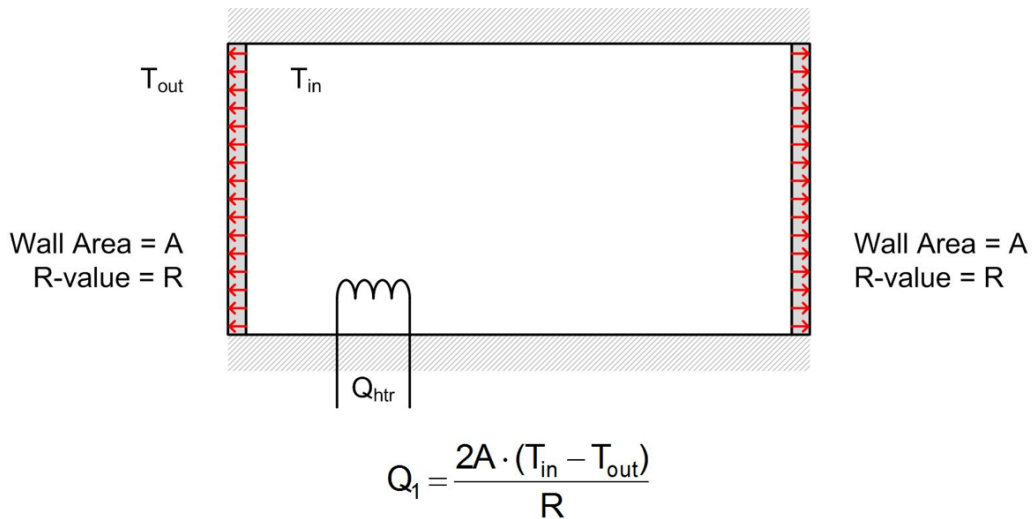
Figure 50 – Simple Conduction-Only Building Enclosure Heat Loss Model (i.e. no Air Leakage)

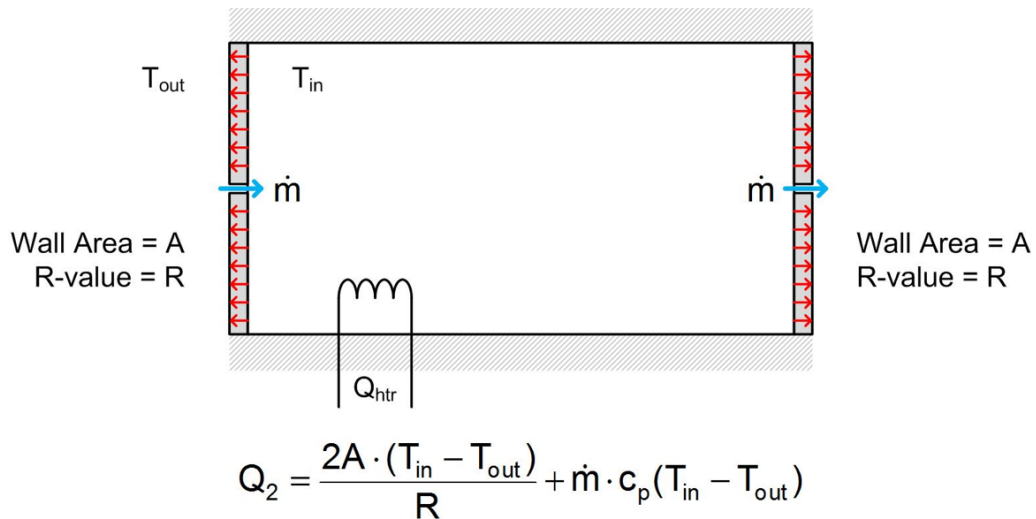
Figure 52 – Simple Building Enclosure Heat Loss Model with Discrete Air Leakage

Typical building enclosure heat loss models, such as the one represented in Figure 52, treat air leakage as if it occurs through discrete holes and does not interact with conductive heat flow through the assembly. This approach can be used to predict the energy associated with the airflows and temperature differences measured in the TM induced infiltration and exfiltration tests. The air leakage energy flow can then be added to the "sealed" heat flow to predict the total heat flow associated with the temperature difference and air leakage. These totals are represented by the red bars in Figure 53.

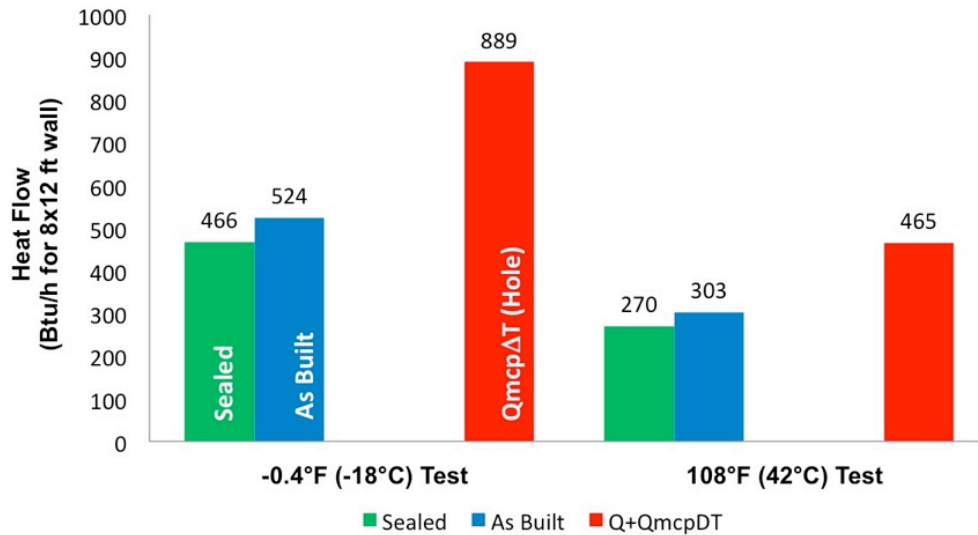
Figure 53 – Measured Heat Flows vs Predicted Airflow Impact for Wall 2 – Inset R13 FG batt

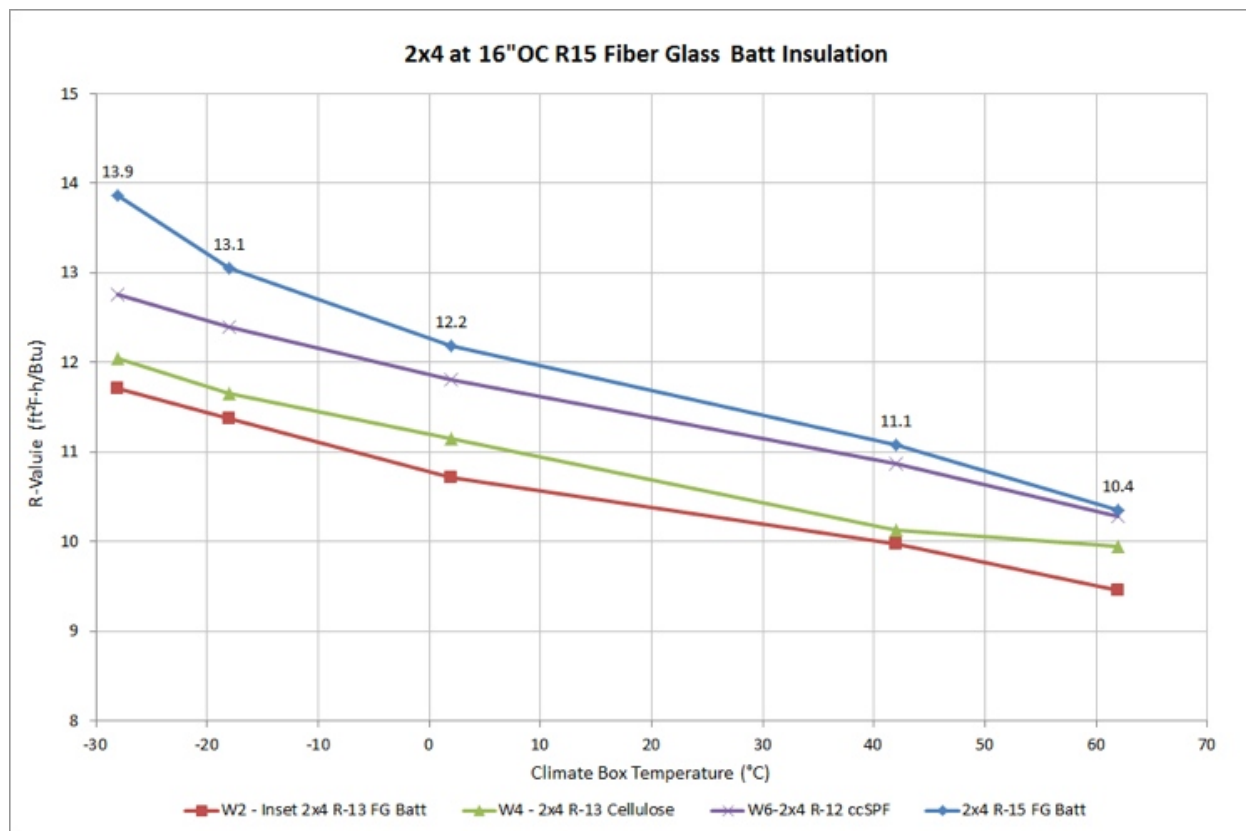
surface-to-surface (S-S) temperature difference by the inverse of the total heat flow. The R-values at each climate box setpoint, including the induced air flow R-values, are provided in the plot below.

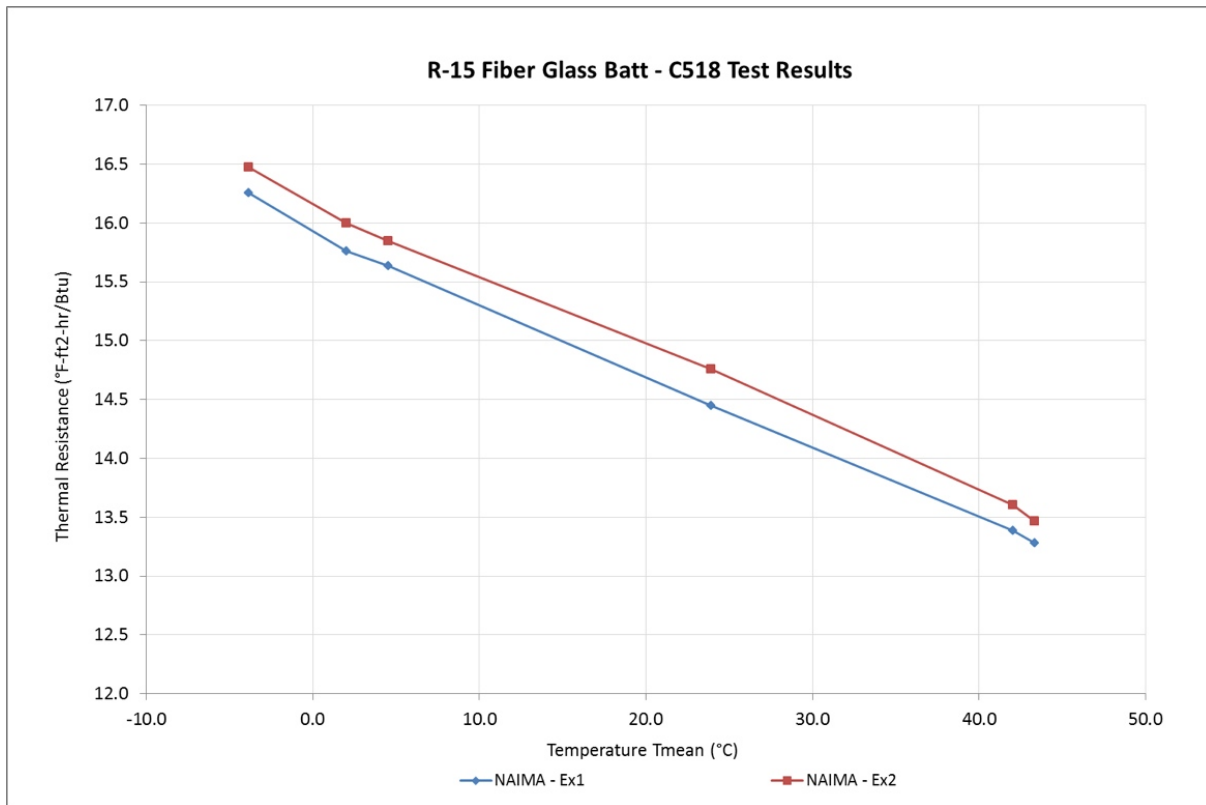
The thermal resistances calculated for each T_{mean} used in the C518 testing are presented in the plot below.
